Full-Scale Crash Test of a Civil Helicopter

Japan Aerospace Exploration Agency (JAXA)

**The Fourth Triennial International Aircraft Fire
and Cabin Safety Research Conference, November 15-18 2004**

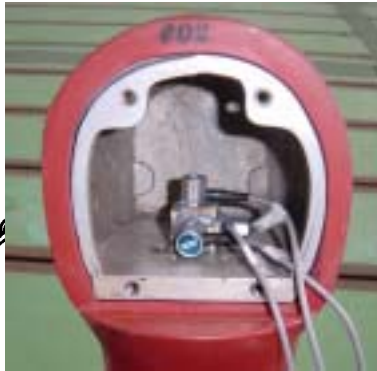
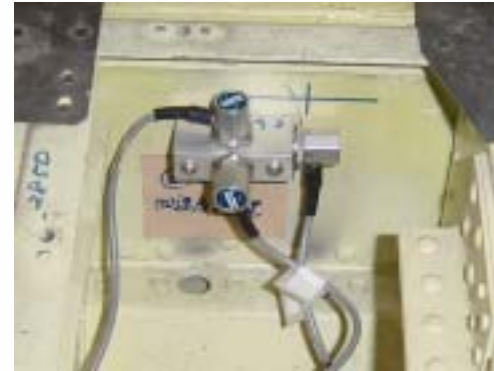
Sensor Installation

Main Frame

STA4735

STA5455

- Accelerometer (140 DOF in total)
- Strain Gauge (45 DOF in total)

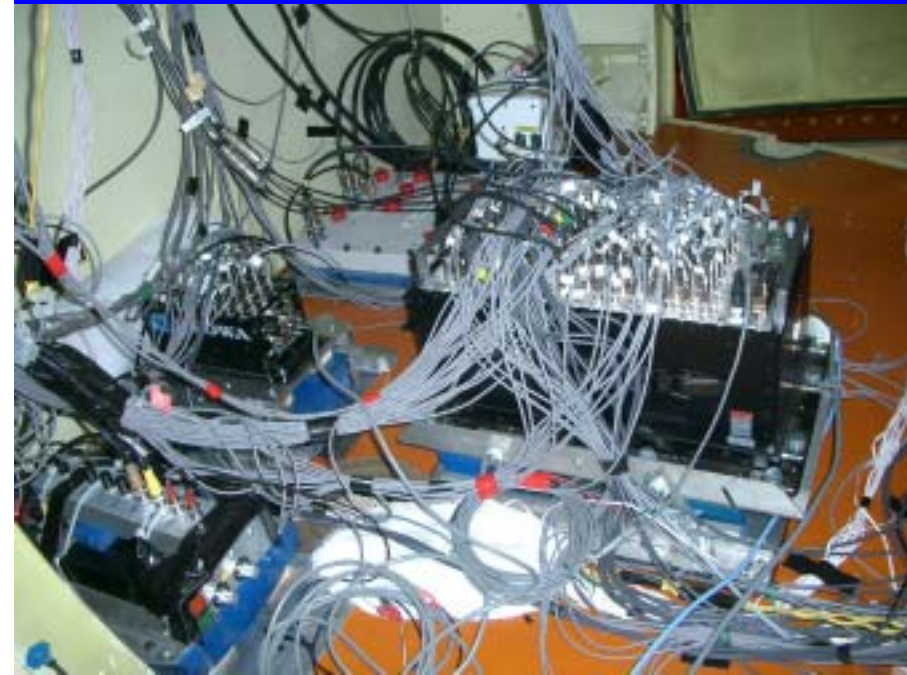
Pretest Overview of Onboard Measurement Devices

Onboard data acquisition systems

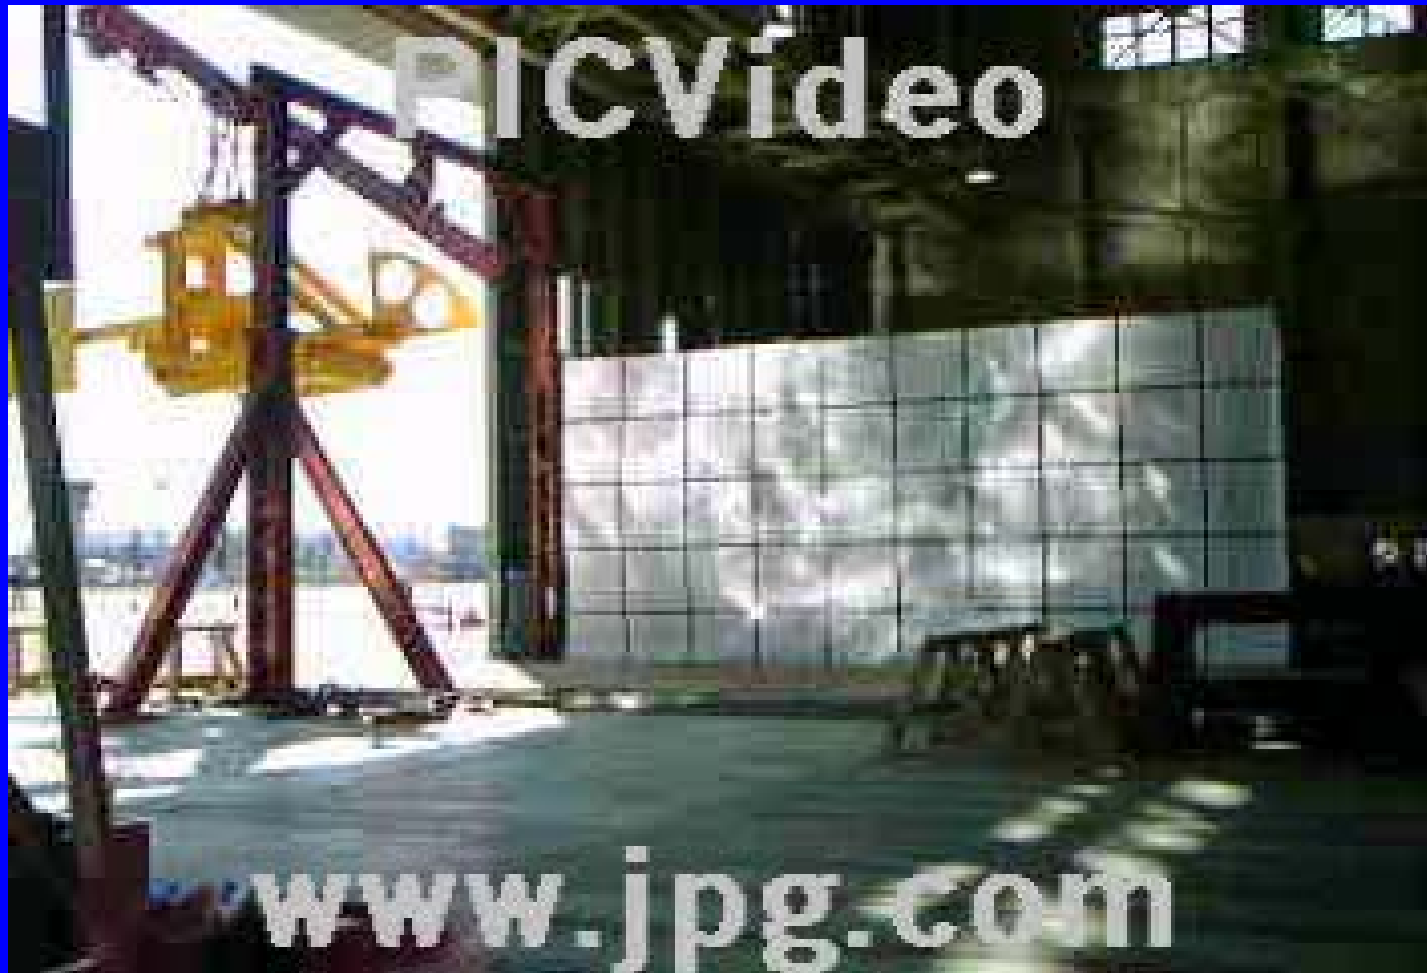
Four Meter High Mock-up Test

Mock-up test:

2m

4m

5m Step-up verification of our test method¹⁵

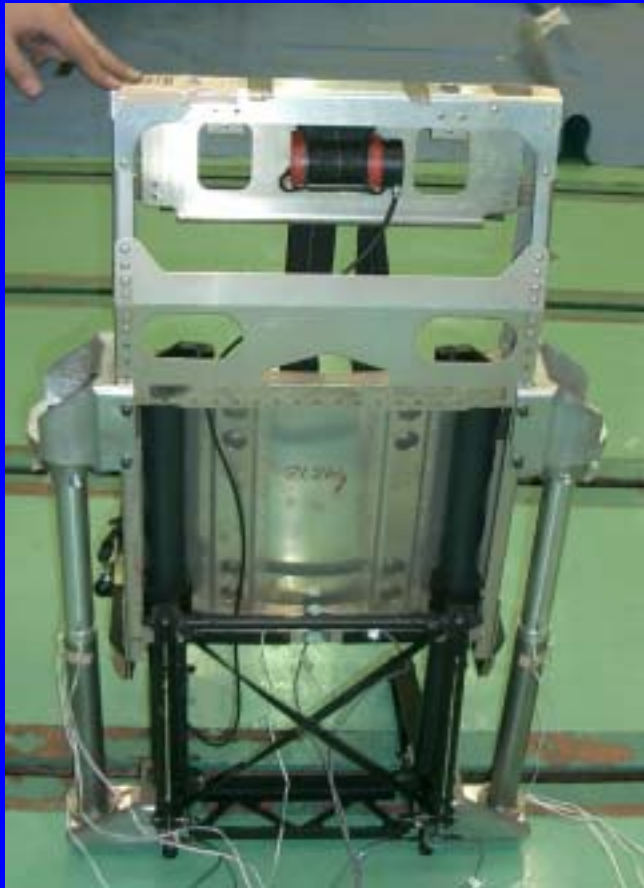
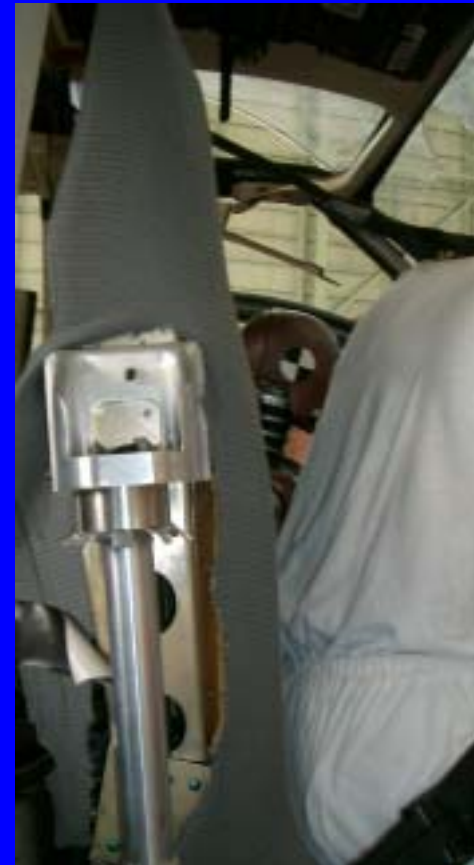
JAXA Energy Absorbing Device

Pretest

Post-test

Did not function properly due to off-axis loading
